TIME DEPENDING DEFORMATION OF PRE-POST TENSIONED BEAMS

The paper deals with investigation of deviations of actual cambers from predicted values that were observed on precast bridge girders where prestress transfer is divided into two stages. The first part of prestressing is introduced by pre-tensioned strands only 18 hours after casting and the second part by three post-tensioned draped tendons stressed one or two month later. The problem is analyzed from structural and technological aspects.

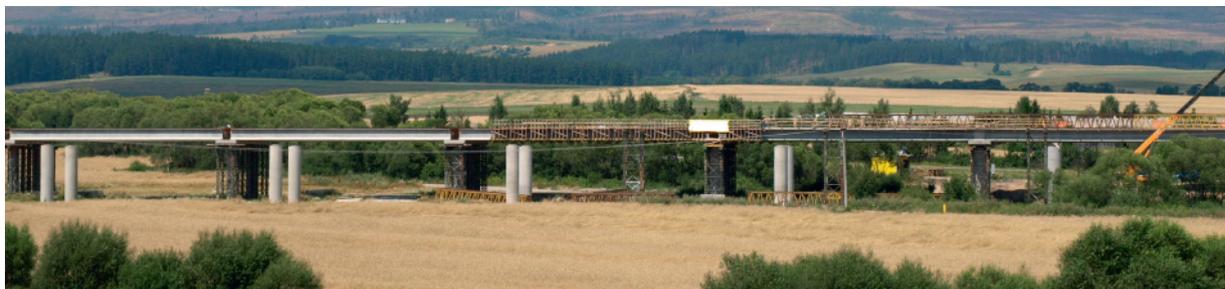
most frequent options of long elevated highways construction in Slovakia. These bridges were mostly composed of 32 m long precast beams DPS VP I-04, see Fig. 1.

Figure 1.
Elevated highway built from DPS VP I-04 beams in the city of Poprad

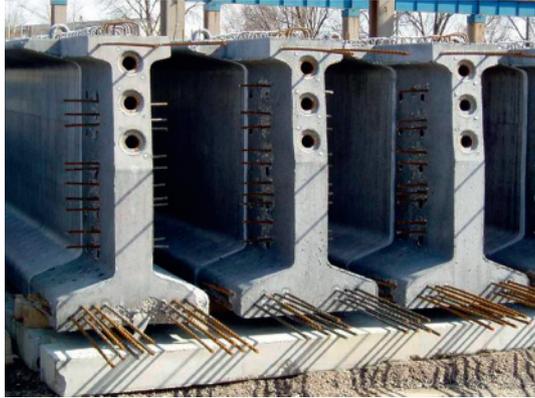
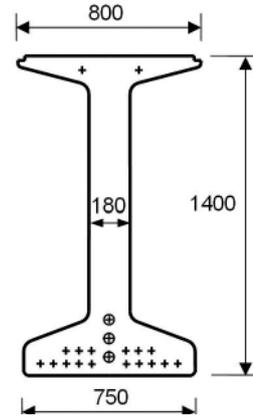
Figure 2.
Beams DPS-VP I04 at storage yard

Detailed monitoring was carried out on four 32.1 m long precast beams. Beams N1 and N2 were pre-stressed with 16 strands in the bottom flange and with 2 strands located in the upper flange, see Fig. 2. Beams N3 and N4 had the same strand lay-out,

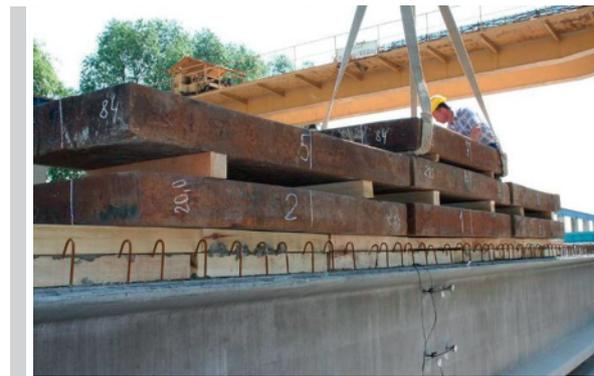
Load test was performed on selected beam prestressed only by pre-tensioned tendon. Prestressing, self weight and testing load should generate tensile stresses up to 3 MPa in the extreme fibres if prestressing force is fully introduced in beam. Because beams were cast of concrete C55/67 no cracks were expected at that moment. Opposite, if prestressing is not properly introduced due to e.g. loss of the bond, the cracks should have developed. Tested beam had deflection of -2 mm while predicted camber was $+8 \text{ mm}$.

Figure 3.
Load test of the 32 m long DPS VP I-04 beam

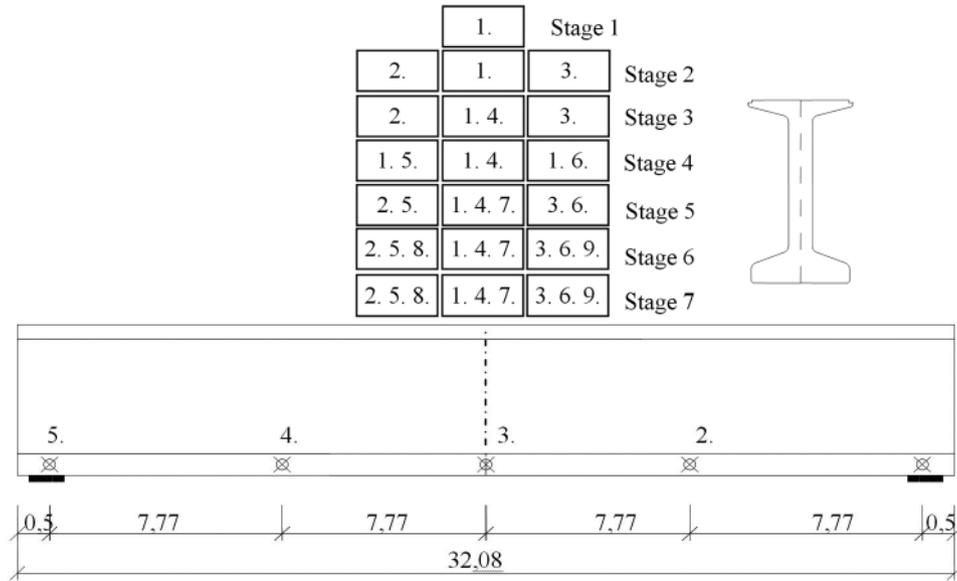
Figure 4. Arrangement of testing load

Testing load consisted of nine steel plates with dimensions of 2.1x0.85x0.21 m each having weight 2.93 metric tons (29.3 kN). The maximum load (stage 6, 7) represented 41.85 kN/m on the length of 6.4 m. The maximum load was kept on the beam for 60 minutes. Load arrangement is presented in Fig. 4.

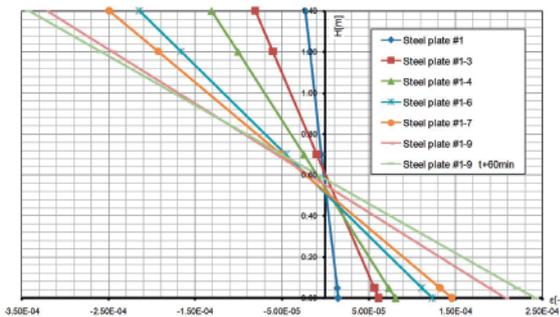
values are shown in Fig. 5. Measured value of 210 microstrains in the bottom shortly after full loading was lower than predicted value of 240 microstrains. Opposite measured deformation of 320 microstrains in the top was higher than predicted value of 300 microstrains.

The measurements indicated non-homogeneity of cross-section along the beam depth and explained larger deflection than it was predicted. Visual control of the bottom flange did not reveal any cracks in the tested beam.

Figure 5. Strain distribution due to testing load

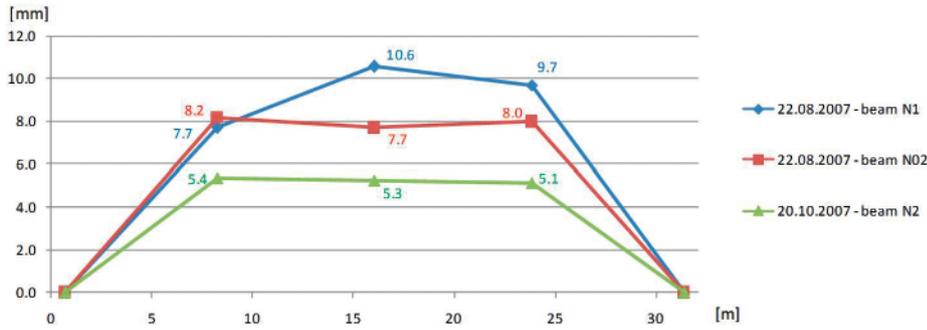
Figure 6. Cambers of the beams just after prestress transfer in formwork

the last one during stressing of post-tensioned tendons. Measured deformations just after prestress transfer of pre-tensioned tendons are presented in Fig. 6.

Applied prestressing forces had always lifted beams at the mid-span and measured cambers were even higher than the predicted value of 7.5 mm for several monitored beams. However, beams began to loose their camber within several minutes, see Fig. 7 and Fig. 8 and original cambers changed into deflection in many cases contrary to the prediction when incre-

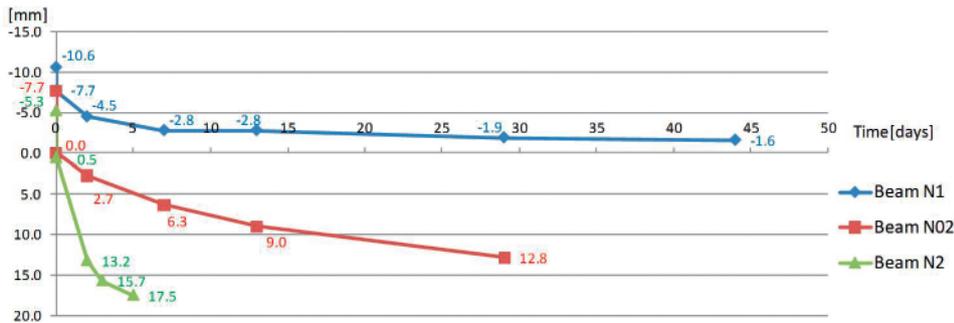
Figure 7. Development of cambers in the mid-span of the beams

Time development of the concrete strains is shown in Fig. 13 and Fig. 14. Increment of strains (shortening) measured by upper strain gauges has always been larger than in lower ones. It confirmed development of deflection of beams see also Fig. 7, particularly for beam N2. These deflections were not result of long-term prestress losses, because e.g. the prestress losses in beam N2 were only -17 MPa within 5 days.

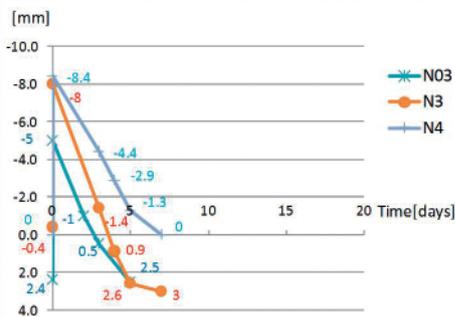
Figure 8. Development of cambers

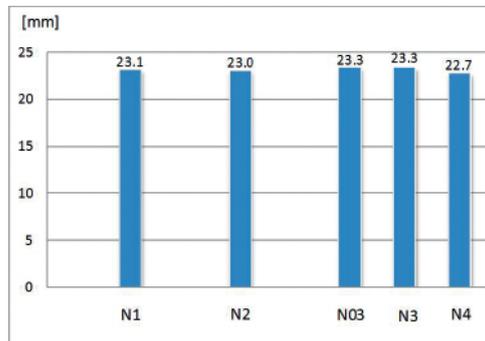
Figure 9. Deformations due to post-tens. tendons

ment of cambers was expected. The same behaviour was observed on the beams N3 and N4 with separated upper strands. Very typical was large scatter of deformation. Much better results were obtained during stressing of post-tensioned tendons. Measured deformation due to effect of three four-strand tendons is shown in Fig. 9. Increment of cambers was ranging between 22.7 mm and 23.2 mm. This results were also in very good coincidence with predicted values 22.8 mm. Assessment of beam deformation was carried out assuming high-performance concrete C55/67 and average modulus of elasticity 45 GPa.

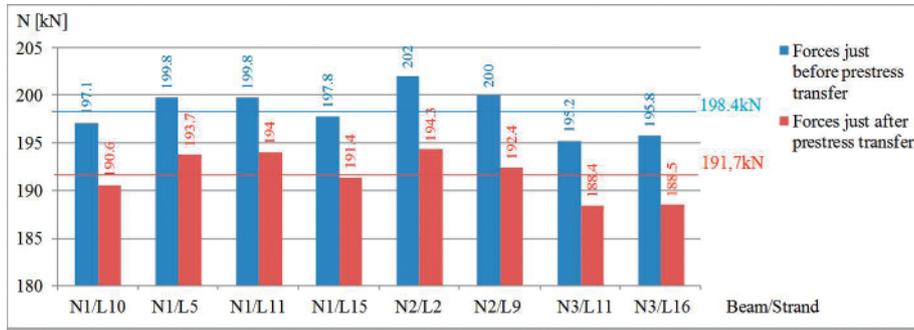
Figure 10. Measured prestressing forces in the bottom strands

Comparison of prestressing forces in monitored pre-tensioned tendons located in bottom flange is shown in Fig. 10. Average value of prestressing force per strand before transfer was 198.4 kN, while minimum projected value was 192 kN (used in design). Average value just after transfer was 191.7 kN. It means that immediate losses due to elastic shortening of concrete were on average -6.7 kN (-47 MPa), while predicted value was -6.9 kN.

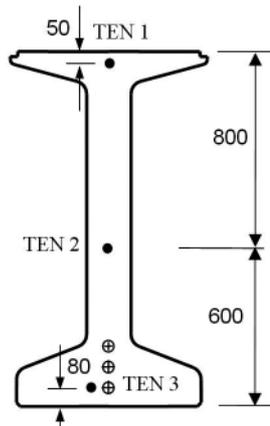
Figure 12. Position of tensometers

Concrete strains were measured with highly sensitive strain gauges embedded in sections that were located at mid-span of precast beams. Position of the strain gauges in cross-section is shown in Fig. 12. Three strain gauges were used in beam N1, two in beams N2, N3 and N4 (TEN1 and TEN 3). Theoretical strains were calculated with modulus of elasticity of 18-hours old concrete $E_{c,eff} = 38$ GPa. Corresponding stresses in the concrete were: top of the beam -7.31 MPa, bottom -9.14 MPa. In case of beams with separated upper strands -4.27 MPa and -9.91 MPa respectively.

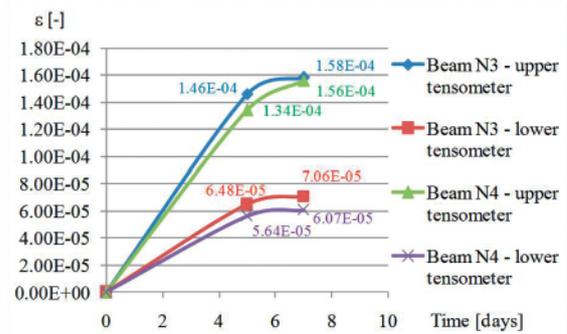
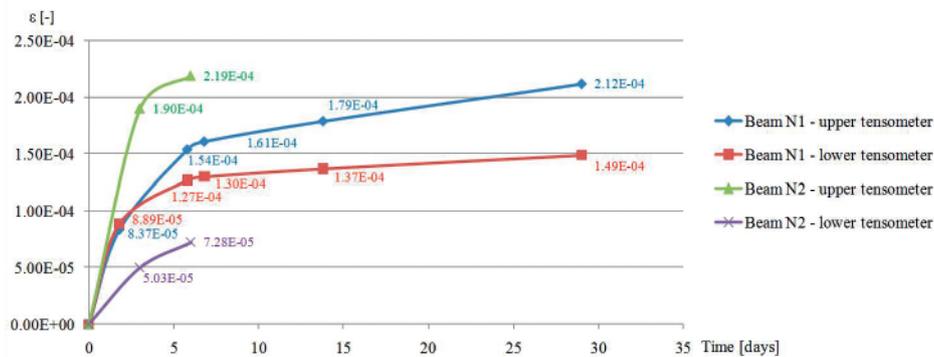
Figure 13. Time development of concrete strains

Figure 14. Time development of concrete strains

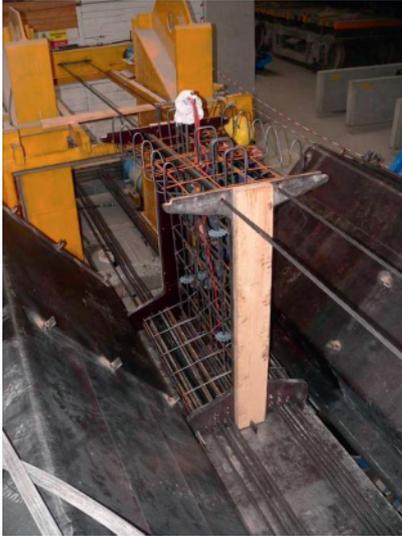
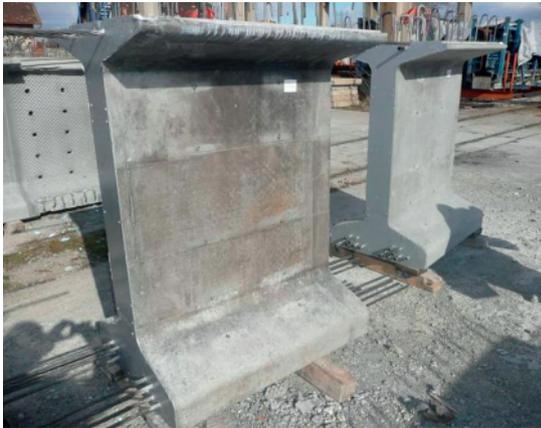
Three 1 m long segments were cast together with precast beams. Segments had the same cross-section as actual beams, see Fig.15 and they remained non-prestressed. Three tensometers were embedded in each segment. The first one was located in the bottom flange 60 mm far from the surface, the second one in the web – upper flange connection and the last one 40 mm far from the top of the beams. Difference between strains measured by upper and lower tensometer allowed us to determine curvature due to uneven

Figure 15. Segment in prestressing bed before casting and segment at the storage yard

Beams DPS VP I-04 are produced at stationary prestressing bed. Formwork is rigid, welded of steel plates, see Fig.15. Steel containers are used for concrete placing. Concrete placing is divided into two

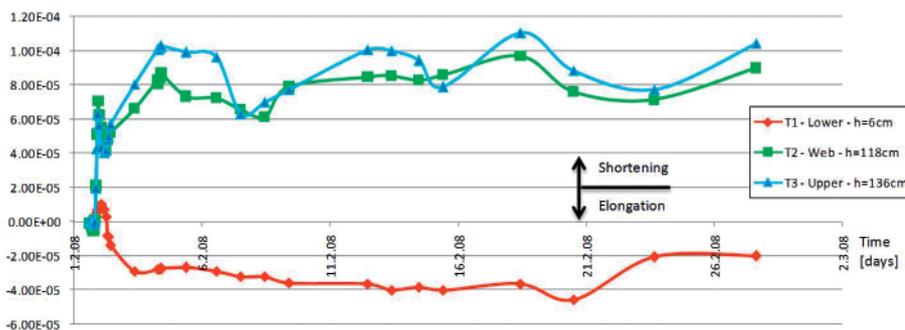
An example of time development of the strains in segment #3 is presented in Fig. 16. Measurements have shown differences between strains of the upper and lower flange, strains in upper flange were larger than in the bottom flange for all three segments. Differences were ranging from 100 to 130 microstrains and thus curvature was ranging from $7.7 \cdot 10^{-5} \text{ m}^{-1}$ to $10 \cdot 10^{-5} \text{ m}^{-1}$. Displacement due to the uneven shrinkage more than -11 mm was determined by numerical integration.

Figure 16. Time development of concrete strains in 3 segment

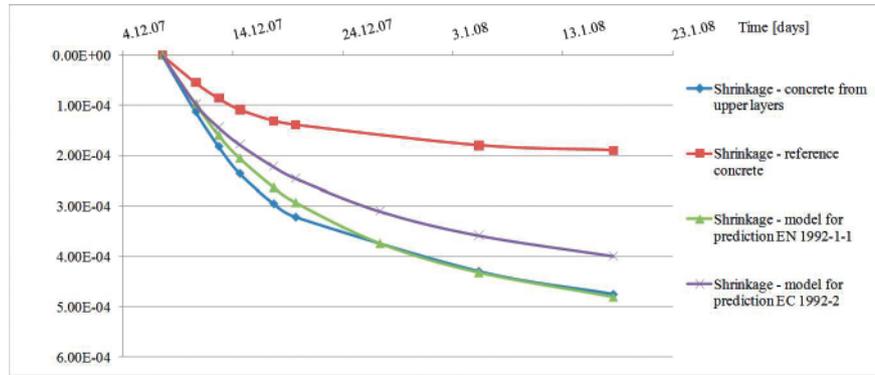
Figure 17. Strains due to shrinkage

crete from upper layers compared to the normal concrete. Very significant are particularly differences between shrinkage of both concretes. Shrinkage of concrete taken from upper flange was two times higher than shrinkage of reference concrete, see Fig. 17.
