ANALYSIS AND DEFINITION OF RESTORATION STRATEGIES WITH H-BIM APPLICATIONS. THE CASE STUDY OF VITTORIO GIORGINI'S "CASA ESAGONO" IN BARATTI, ITALY

Keywords: Casa Esagono; Conservation; H-Bim; Modern Architecture; Vittorio Giorgini; Wooden architecture.

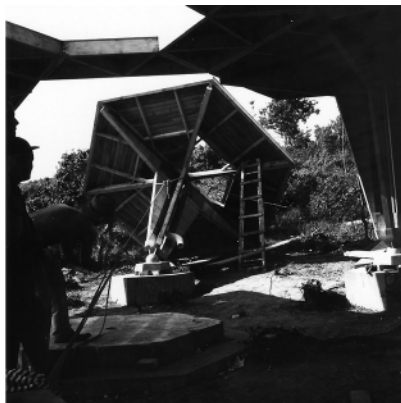
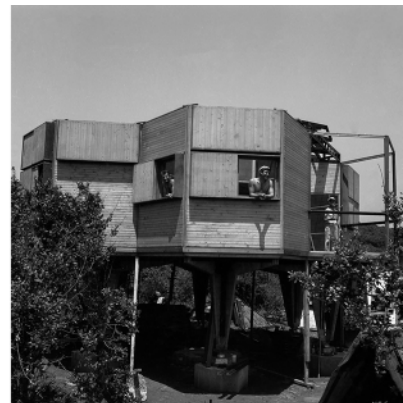
Figure 1.
(left) The model of Casa Esagono and (center and right) the house under construction [source: B.A.Co Vittorio Giorgini Archive]

Giorgini is familiar with the MERO component created by engineer Max Mengerhausen, and with the connecting joints designed by Konrad Wachsmann for the US Air Force. He ponders the hexagonal model of Buckminster Fuller's Dymaxion House of 1929 and is aware of the design path of some of the most innovative architects, engineers and artists of the time, such as Frank Lloyd Wright and Le Corbusier. The prefabricated modular elements of the Casa Esagono arrive on-site ready for installation (Fig. 1).

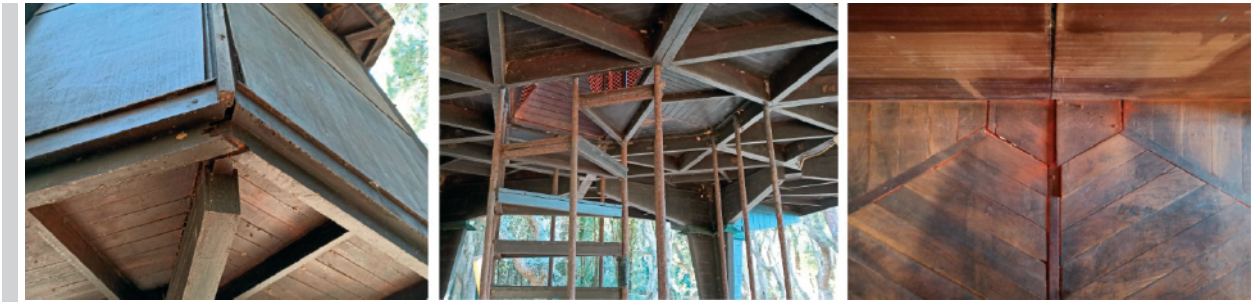
Figure 3.

Loosening of slab joint, stair's structure corrosion, flooring and wall cladding deformations [source: photo by S. Landi]

The cladding intervention in the 1990s, beyond making the house look very differently than in the historical photos, makes it impossible to verify the state of conservation of the perimeter walls, which should be assessed after the removal of the plywood panels. From what could be observed, the two main problems with the house structure are the loosening of several joints at the main floor slab perimeter, where some past temporary repairs are visible, and the advanced state of corrosion of the stairs structure and the floor slabs bolted joints, due to the exposure to the coastal environment. The joints between the plinth and the pillar, instead, are in good condition thanks to the protective paint layers applied. As for the interior, Casa Esagono is almost bare of most of its original furnishings. The interior cladding shows chromatic alteration, stains and deformations of varying degrees caused by humidity, which in some cases have led to cracks. The ceilings show dark stains due to water infiltration. The floorings, near some of the structural joints, shows deformations and rotting due to incoming moisture caused by the same loosening of the joints. Over the years, some degraded parts have been replaced, in particular, wall panels, some doors and windows (Fig. 3).
